# NAPILI 4/5

# CULVERT REPLACEMENT

## PROJECT SUMMARY

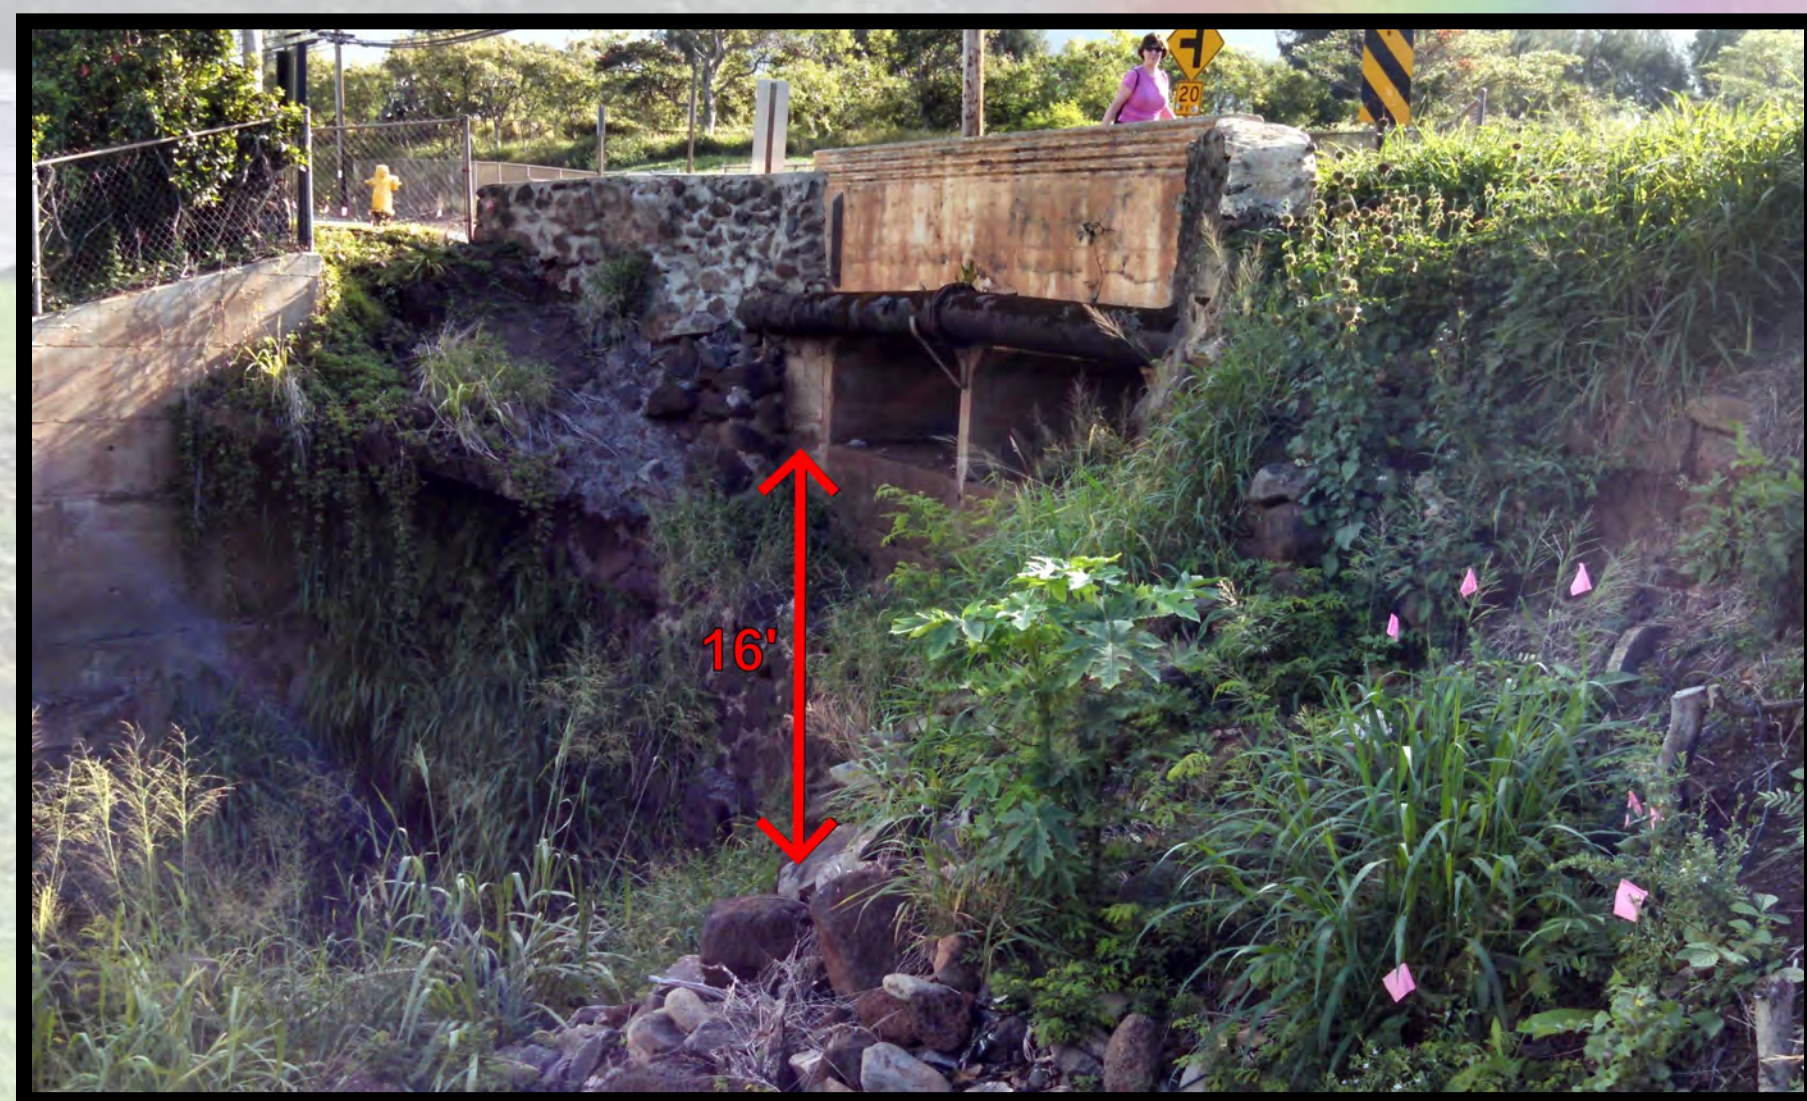
**BEFORE:** Old, deteriorated drainage structure. 16-foot drop from culverts resulted in flooding on roadway above.

- **Develop options for elevation difference.** Stormwater from drainage culvert outlet dropped 16 feet to drainageway below. Various options were developed. Option selected for construction included lowering culvert to outlet elevation and regrading mauka drainageway.

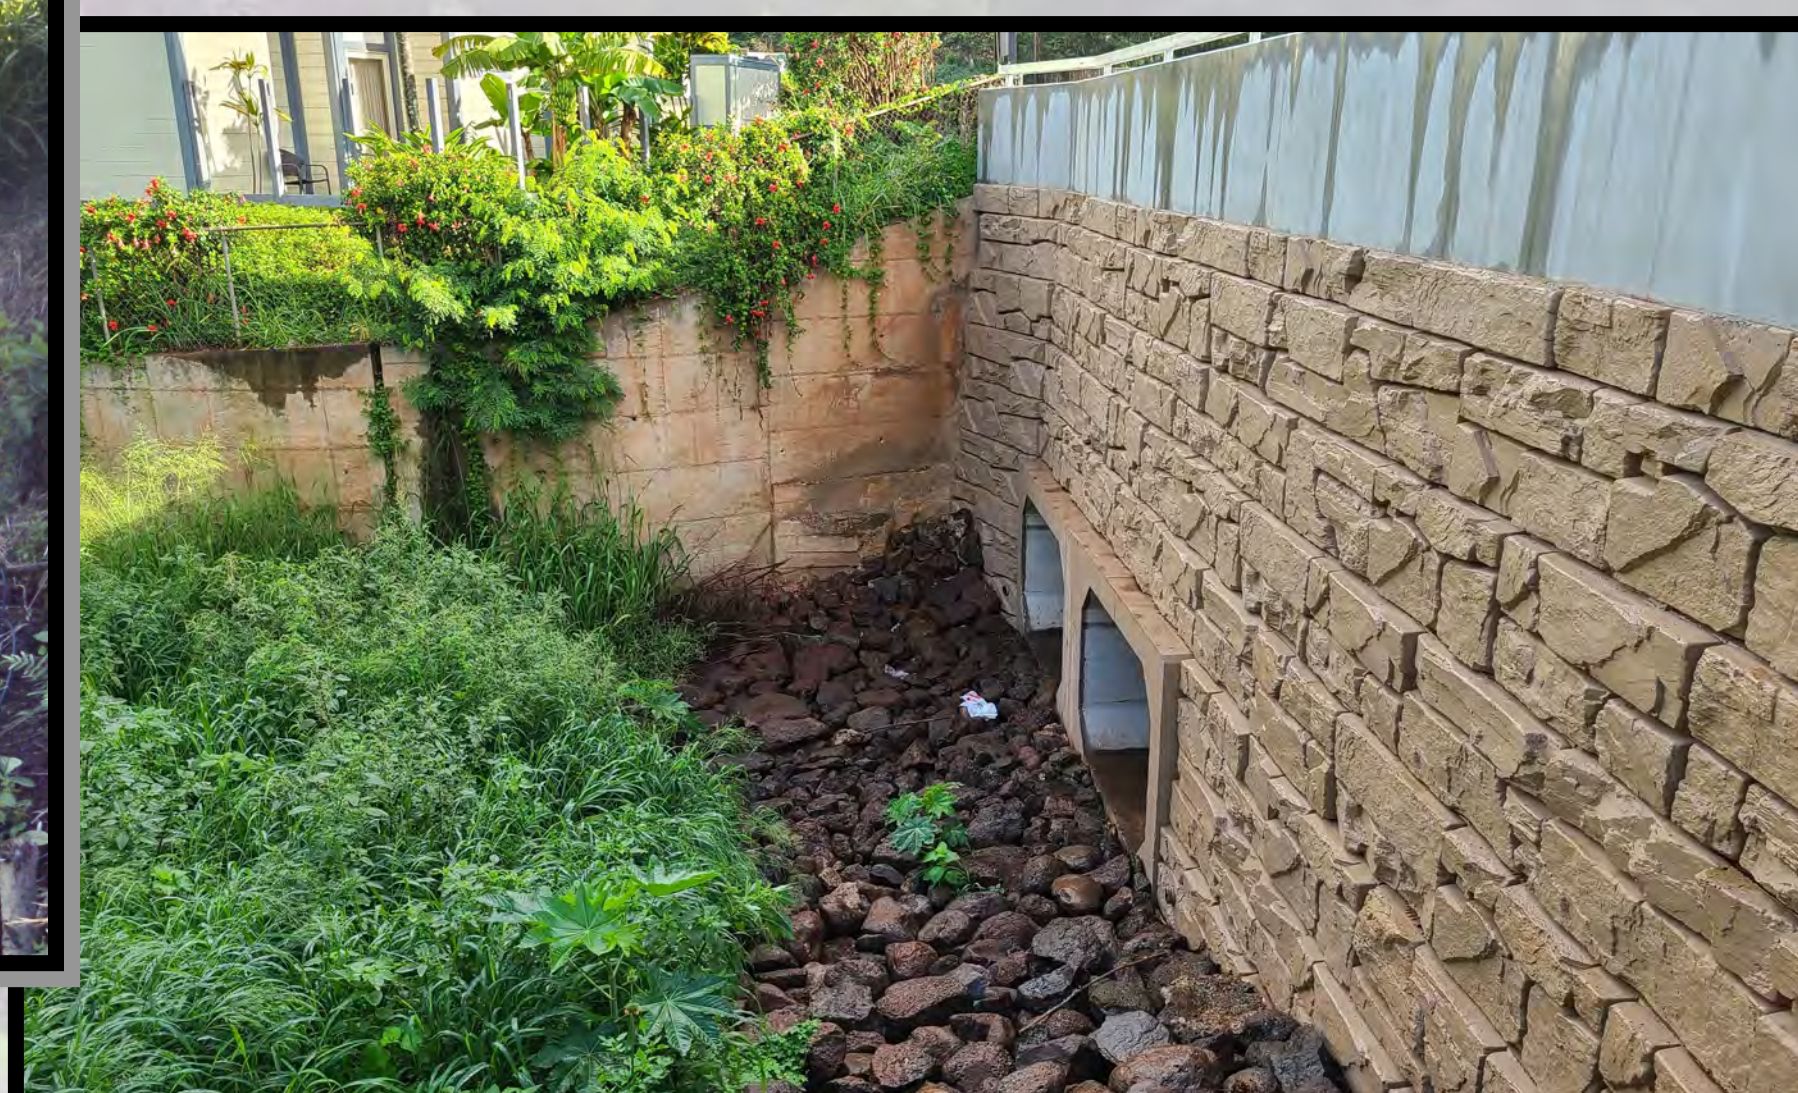
**AFTER:** New drainage way, featuring lowered precast drainage box culverts.

The project involved removal of the existing box culverts and replacement with two (2) new 8-foot by 5-foot precast drainage box culverts. The proposed work also included installation of associated inlet and outlet structures; Armor Flex articulated, open-cell concrete mat within the mauka drainageway; ungrouted riprap on the makai side of the drainageway; and a retaining wall along the adjacent property to the west of the drainageway.

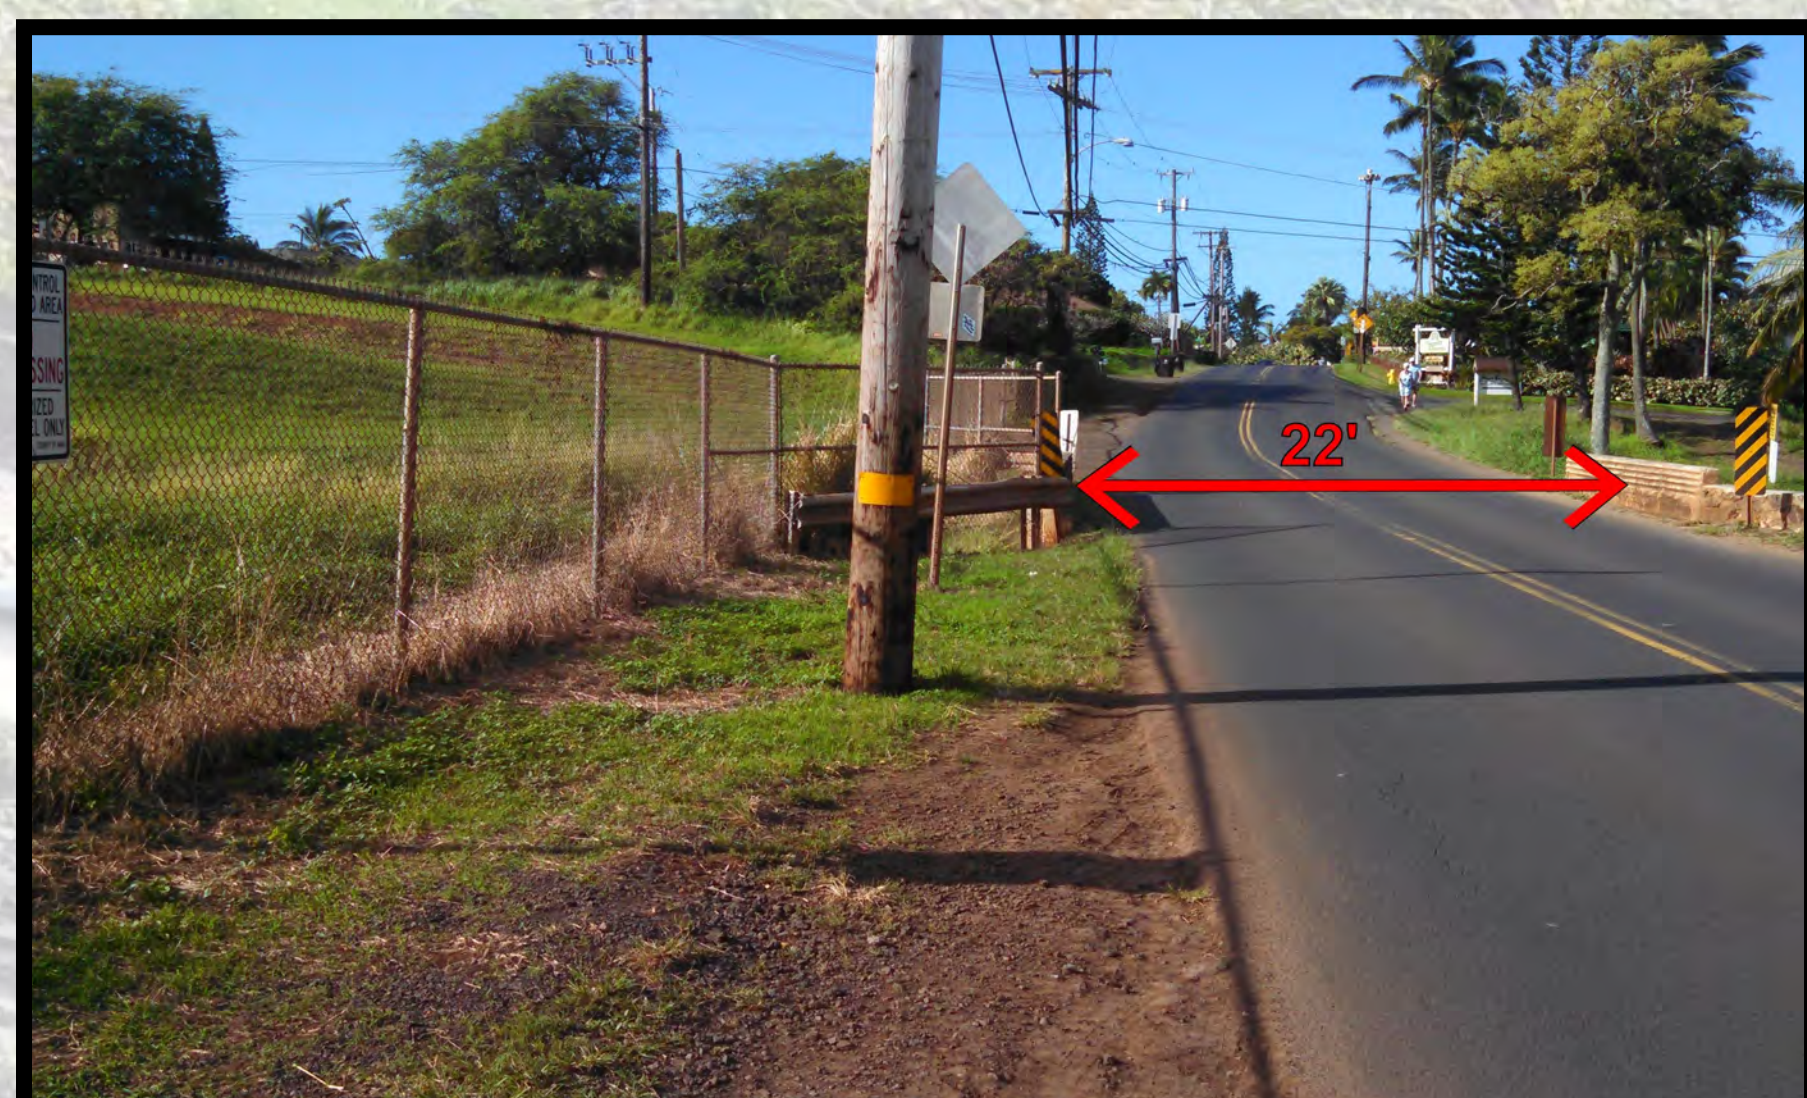
**BEFORE:** Narrow, 22-foot roadway crossing.

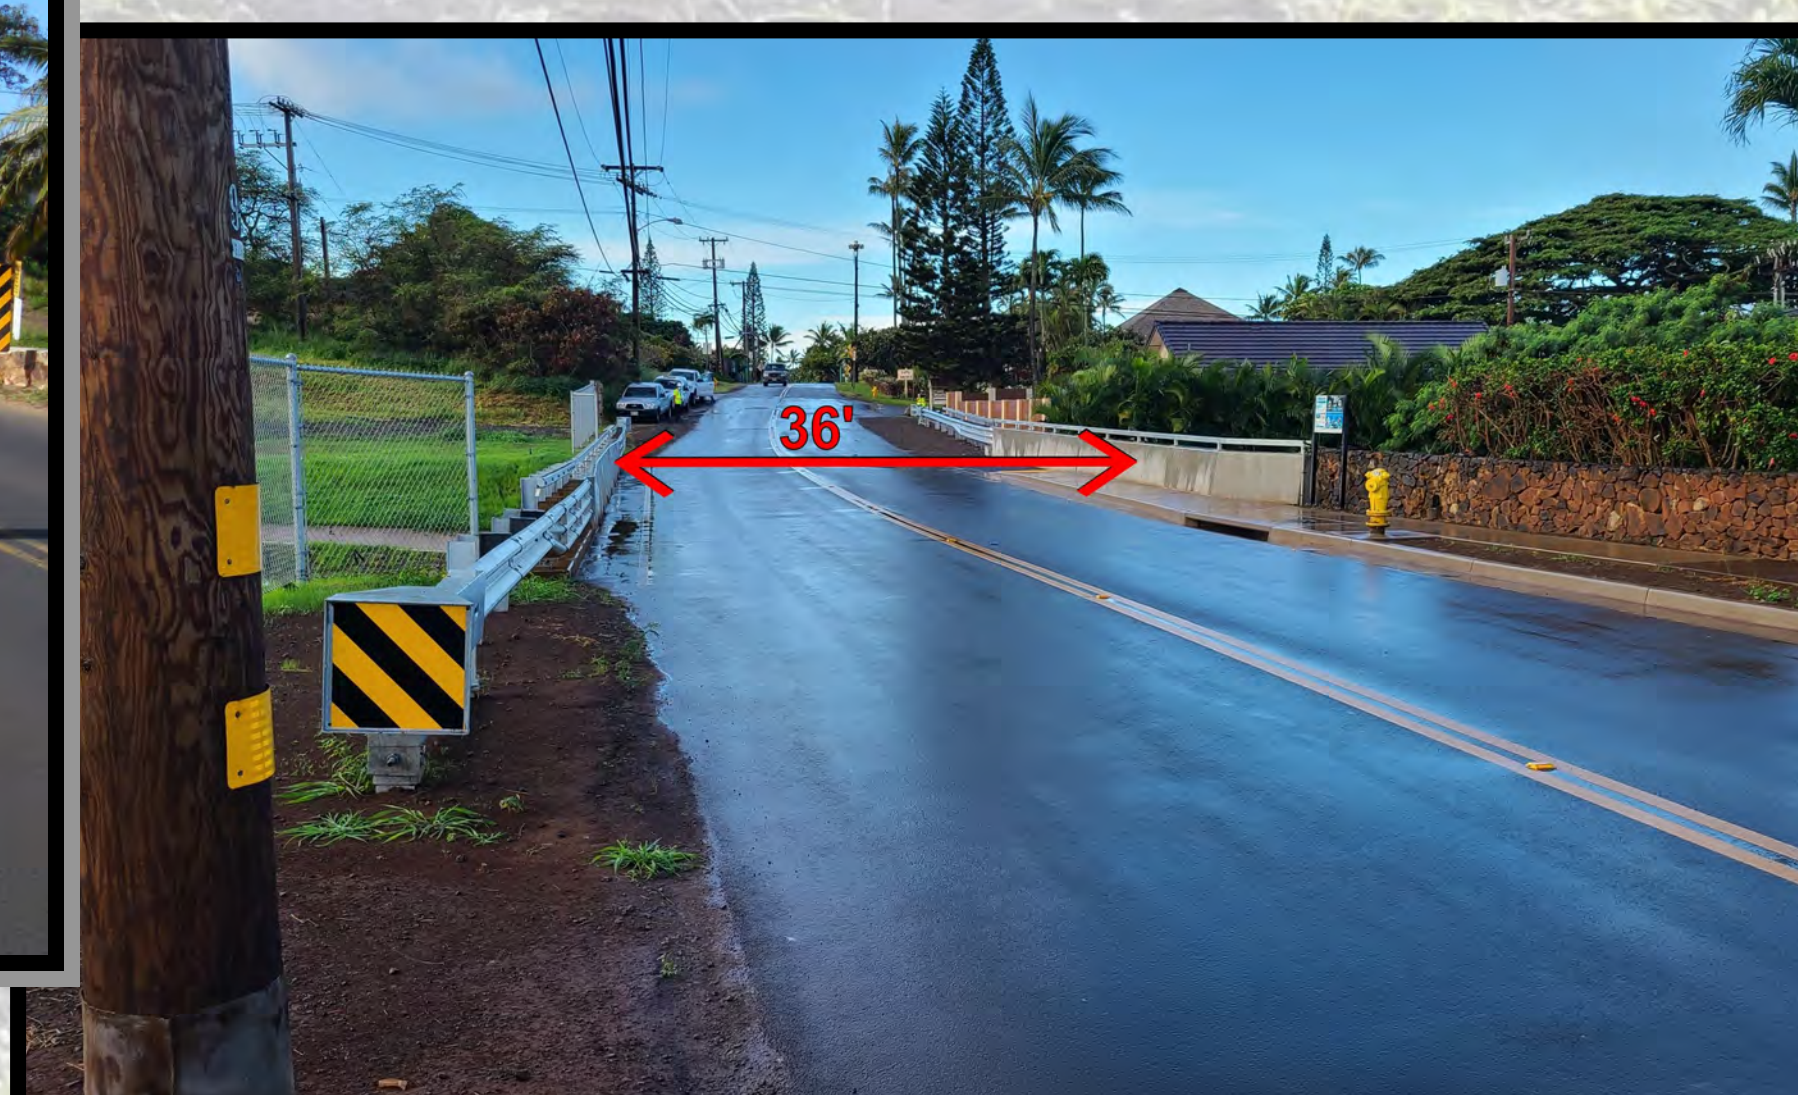
**AFTER:** 36-foot roadway crossing with sidewalk & widened shoulder.

The project incorporated sidewalk and roadway improvements, including widening Lower Honoapiilani Road in the project area from 22 feet to 36 feet. Additionally, the project entailed removal and replacement of a Department of Water Supply water line and Department of Environmental Management sewer force mains.

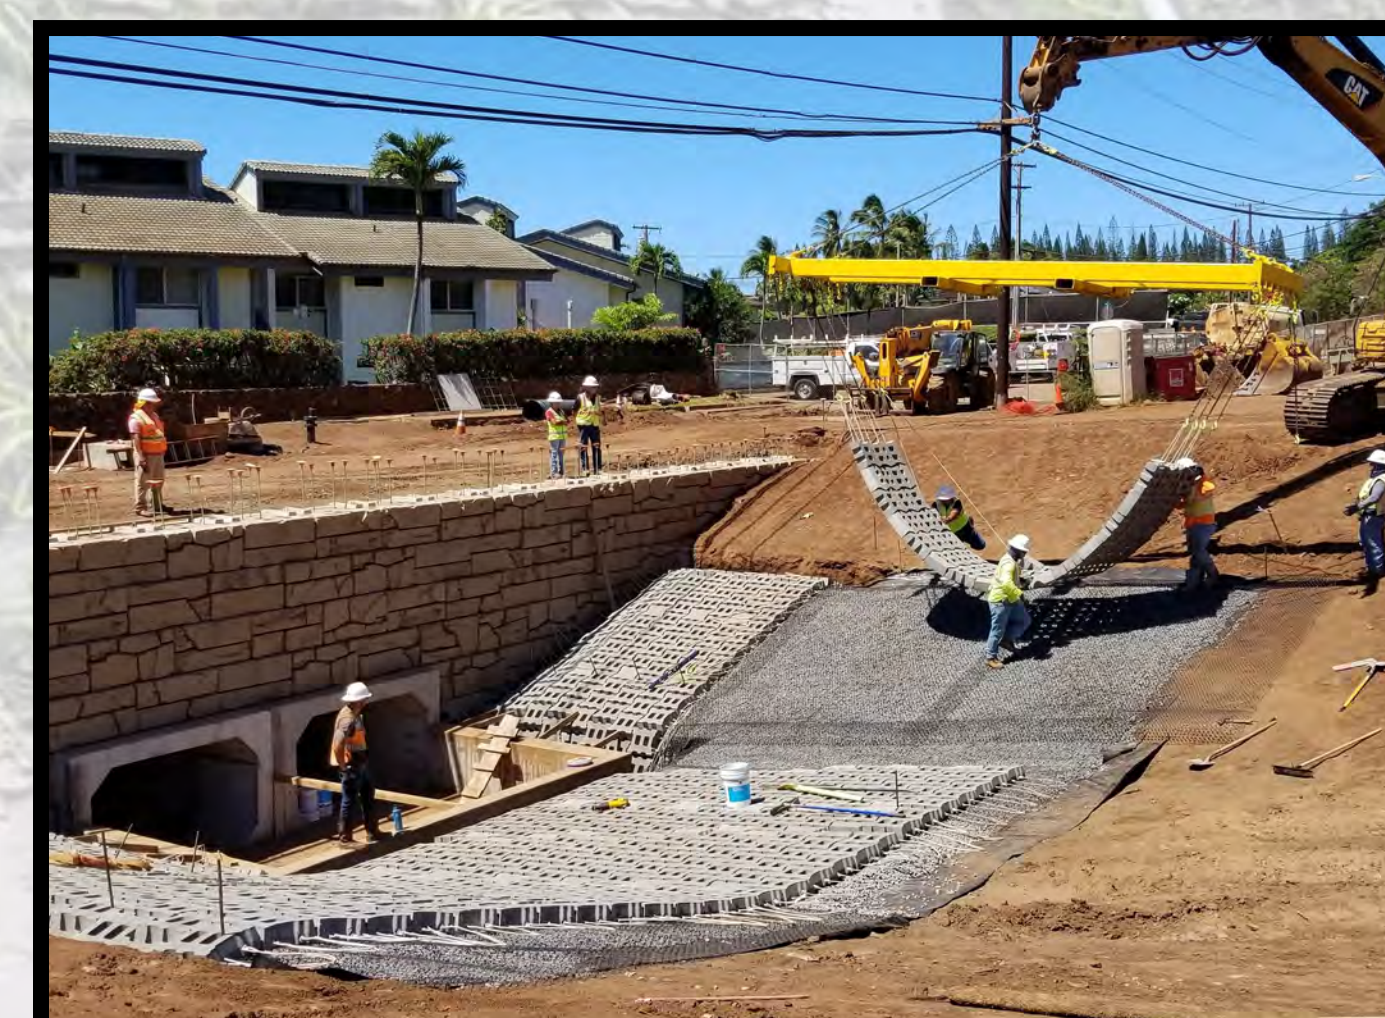
**DURING:** Installing articulated-block mats in the drainageway.

- **High flow velocity.** Multiple vegetated channel lining options were required, but few options were available. Composite turf reinforcement mat was used in the gentler sloped channel. Articulated open block mats were used on the steeper sloped channel.

- **Installed utility bypasses in phases.** Coordination with concurrent adjacent sewer project. Installed two new sewer force mains to be connected at a later date; temporary sewer by-pass still in operation.
- **Native Grass.** Grown in Kaneohe, Oahu and shipped to Maui.
- **Unique materials.** Articulated-block mats were fabricated and shipped in 31 pieces averaging 20 feet in length. Required specific spreader bars for installation.

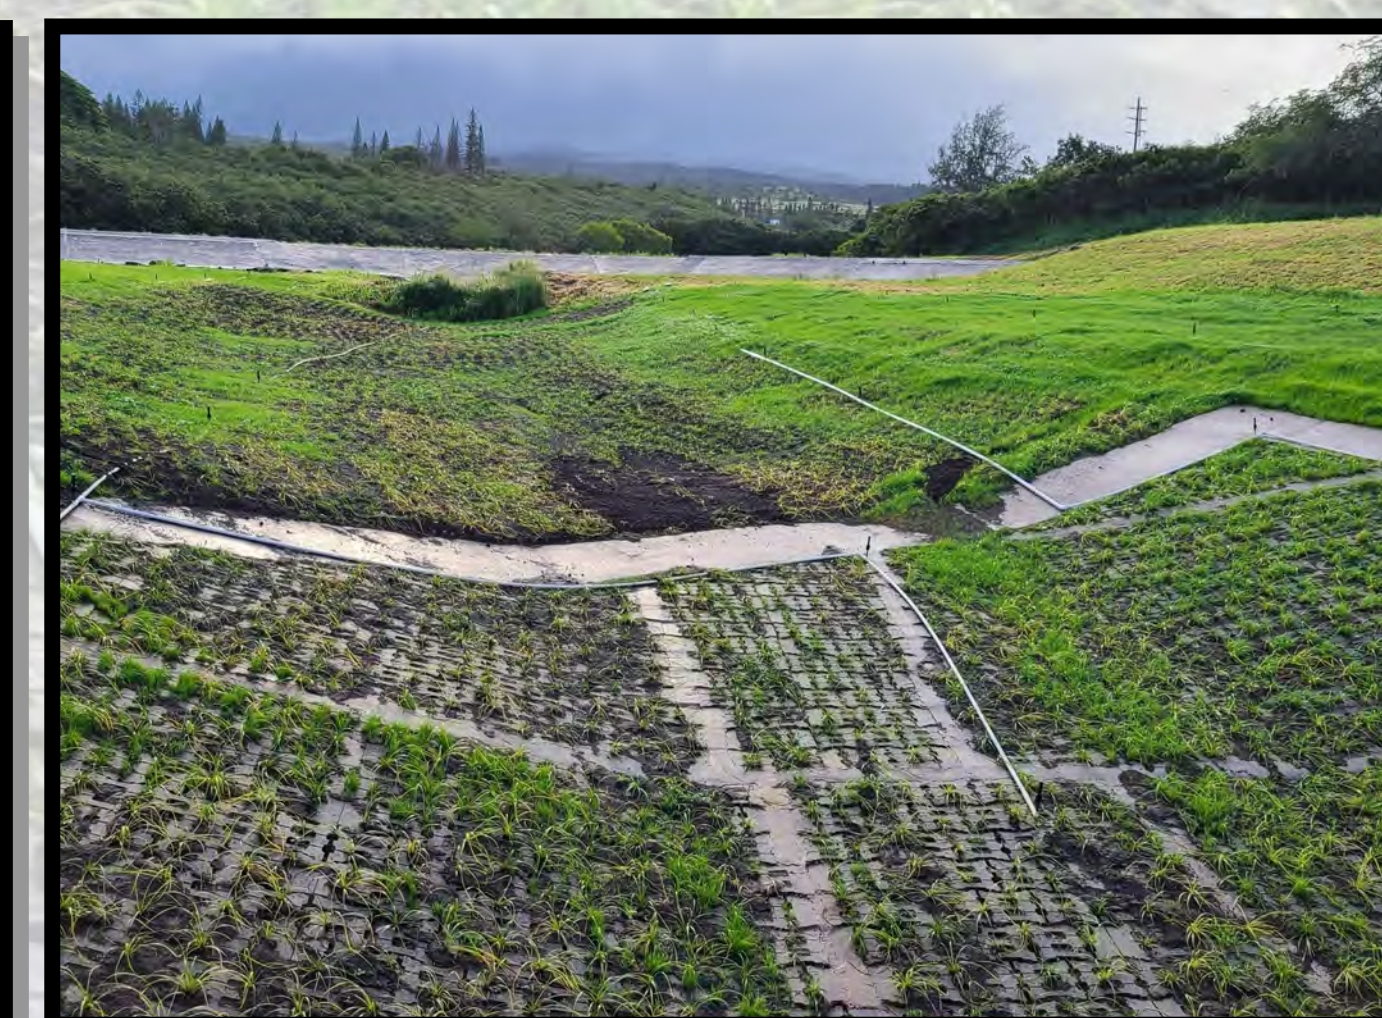
**AFTER:** Native grass planted in the stream & drainageway.

The existing channel was regraded to reduce erosion and improve water quality downstream of the proposed replacement culvert. Native planting material was incorporated into the vegetated portions of the project.
